The direct drum from the 5L40E has two bushings in the support tube. On most applications both bushings are the same I.D., but different O.D. The smaller one, 98409-1 has a single identification ring on the outside of the bushing and **must** be installed first. The two ring bushing is installed last.

Omega Machine & Tool, Inc.

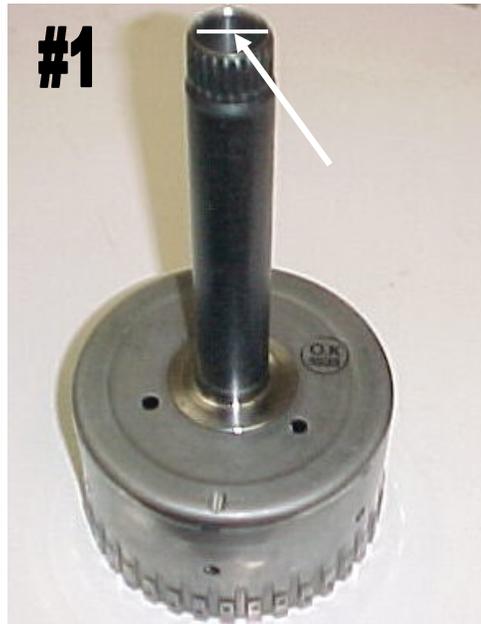
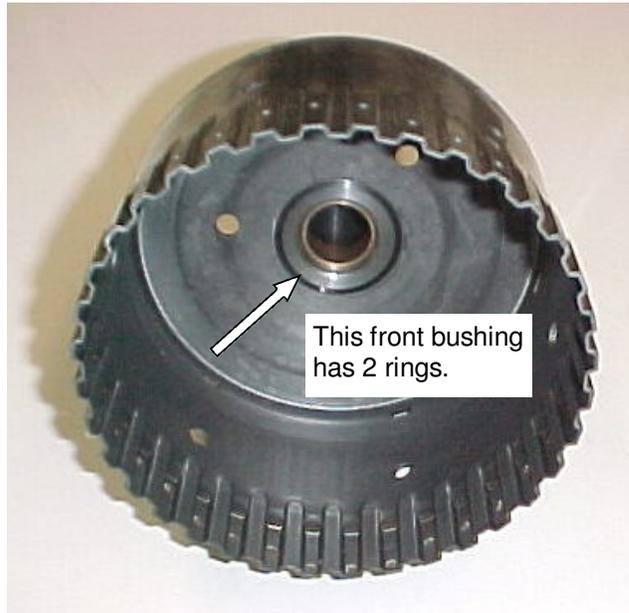
Some of the 5L40E transmissions used in the BMW use two of the smaller 98409-1 bushing with a single ID ring. If you try to install the 2 ring bushing in the front location it will install with much difficulty, and the shaft will not go through the bushing because it has been compressed too much. The diameter of the area designated by the arrow in Figure #1 is 1.024 for the BMW direct drum. The more common 5L40E drum diameter will be .966 and the instruction for installing one bushing first and then the other will apply.

Do not attempt to remove a bronze bushing and re-install it. The bushing will compress at installation and will fail if removed and reinserted.
