09G - TF60SN

Clutch Drum Bushing Case Repair Tool Part # 90330

09G TF60SN C2 Clutch Drum Bushing Repair Tool

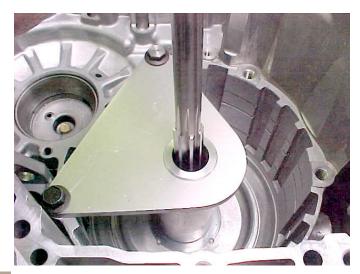
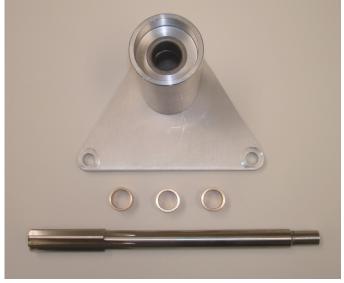
The center post at the rear of the 09G case holds a bushing that tends to ruin the case when it spins. In order to save the cases we have produced an oversize bushing.

Machining of the case is necessary to install the bushing. The sleeve at the rear of the case must fit firmly on the post. Three bushings come with the tool. Omega Machine is please to announce this tool so you can repair these cases in house.
