***Innovative Solenoid Solution  
Addresses Most of the Common  
Vehicle Complaints that are Linked  
to VFS Solenoid Functional Failures.***

## **Ford 5R55N/W/S Solenoid Rebuilding**

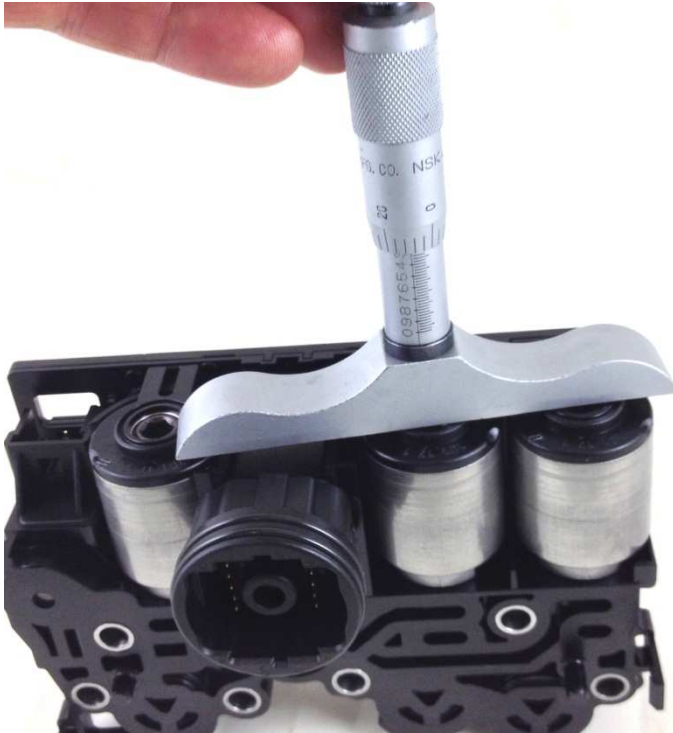
Measure and record the depth of each solenoid plunger bushing.

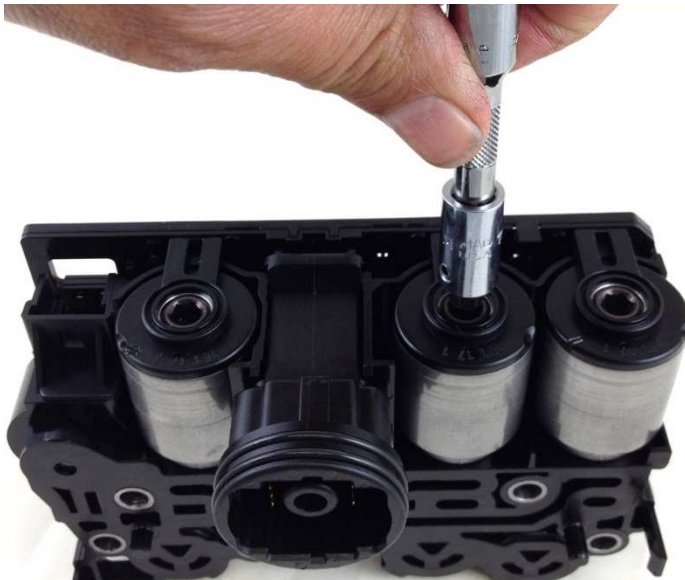
Using a T20 torxe socket remove the plunger bushing from PCA, PCB and PCC solenoid, being careful not to loose the spring between the bushing and plunger.

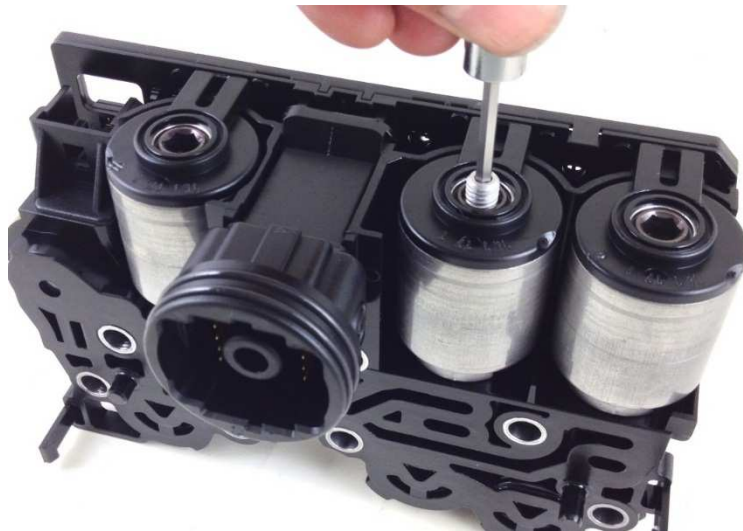
Using a 7/64 allen wrench, install the **Maxx Fluxx™** bushings on PCA, PCB and PCC to the original depth  $\pm 0.002-0.003$
