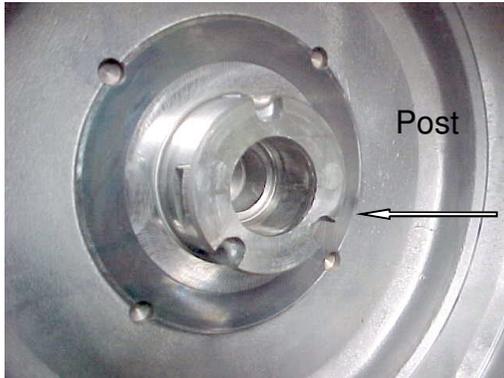
Problem: This post supports a sealing ring sleeve. If the sleeve comes loose, it blocks the port. The bushing in the center tends to self destruct and ruin the bushing fit in the case. This procedure addresses both of these problems.

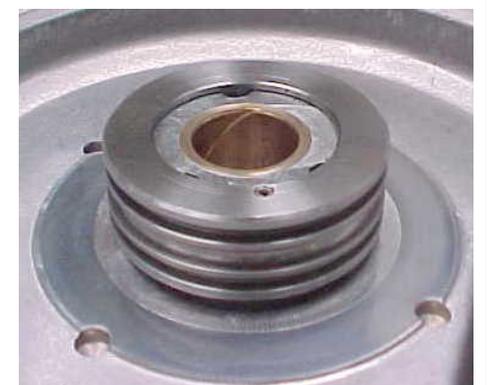
Your finished repair should look like this.
