AW 55-50SN Case Repair
AW 55-51SN

**Before doing anything else be sure to
check the case for wear!**

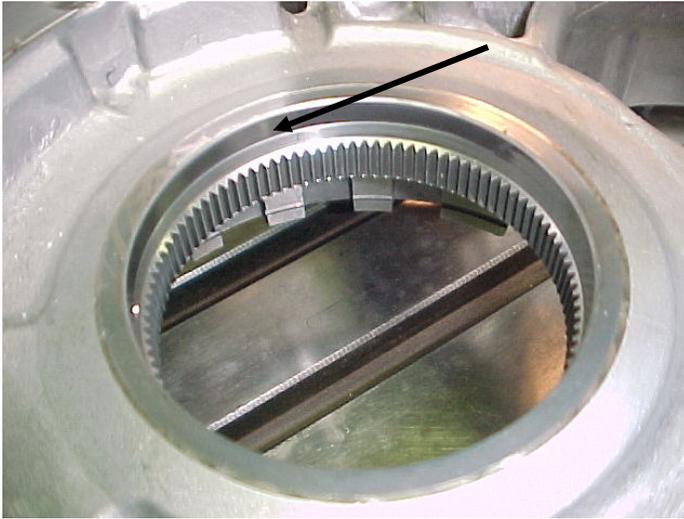
The AW 55-50SN family of transmissions comes in Maximas, Saturn Vues, Volvos, and Saabs. Transmission failure is a result of spun and worn bushings. The case wears and the transmission loses its centerline, causing bushings to fail.

The top picture on the left shows the case wear, where the transfer gear sits in the case. Note the shiny wear mark in the bore.

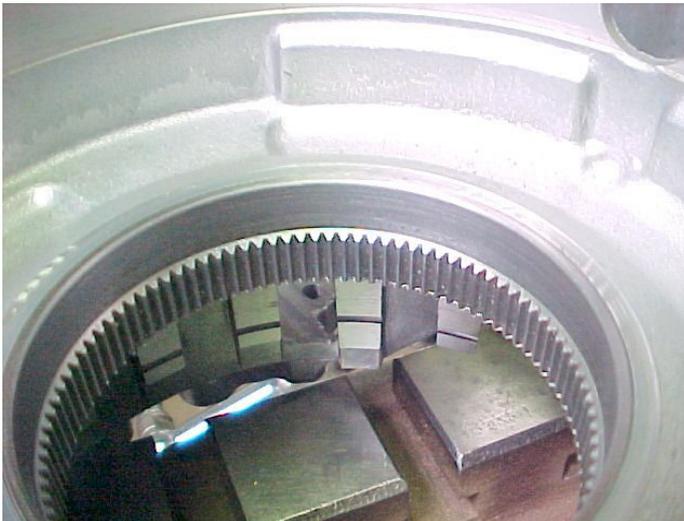
The lower picture is of a case that has been sleeved to restore the stock fit.

One day service is available.
