#1

The direct drum from the 5L40E has two bushings in the support tube. ON most applications both bushings are the same I.D., but different O.D. The smaller one, 98409-1 has a single identification ring on the outside of the bushing and is **must** be installed first. The two ring bushing is installed last.

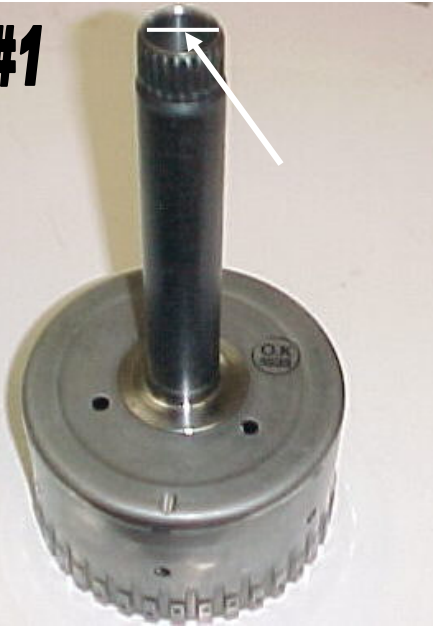
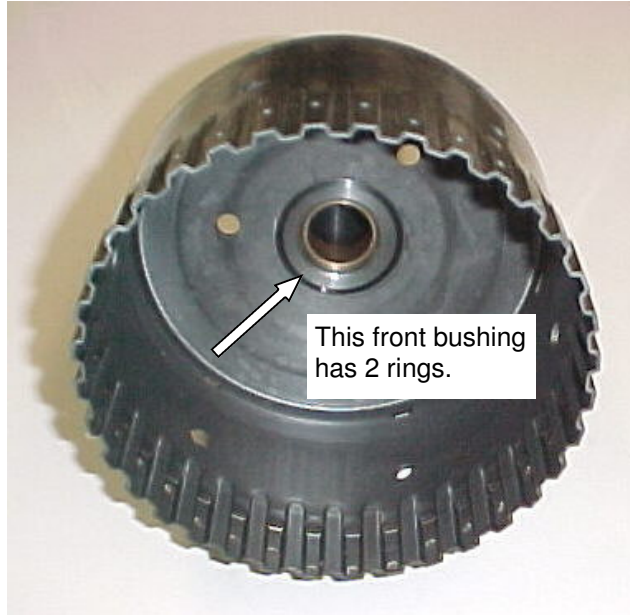
Some of the 5L40E transmissions used in the BMW use two of the smaller 98409-1 bushing with a single ID ring. If you try to install the 2 ring bushing in the front location it will install with much difficulty, and the shaft will not go through the bushing because it has been compressed too much. The diameter of the area designated by the arrow in Figure #1 is 1.024 for the BMW direct drum. The more common 5L40E drum diameter will be .966 and the instruction for installing one bushing first and then the other will apply.

Do not attempt to remove a bronze bushing and re-install it. The bushing will compress at installation and will fail if removed and reinserted.
